Predicting Fatigue and Damaged Modes Due to Defects of Bio-composite Materials

Keywords: Fatigue, Defects, Bio-composites materials, Non-destructive technique

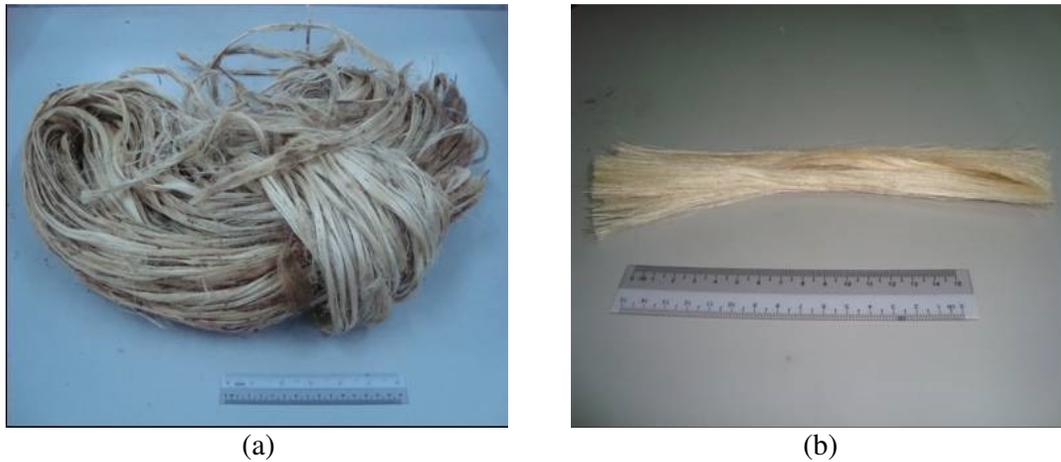
Figure 1(a) and (b): Raw materials of Kenaf bast fibres and unidirectional Kenaf bast fibres after combing, respectively

In this study, the material used was treated Kenaf bast fibre provided by the Institute of Tropical and Forest Product (INTROP), UPM, Serdang, Selangor, Malaysia. The raw Kenaf bast fibres were combed to disrupt and untangle the strong bonds between the individual fibres. Bernard et al. [11] reported that combed fibre exhibits stronger mechanical properties than uncombed fibre. The Kenaf bast fibres were cut to a length of 25cm using scissors. Epoxy with a density of 1.15 g/cm³ was used as a binding material. Figures 1(a) and (b) show the treated Kenaf bast fibre raw materials and the unidirectional Kenaf bast after being combed and cut to 25 cm.

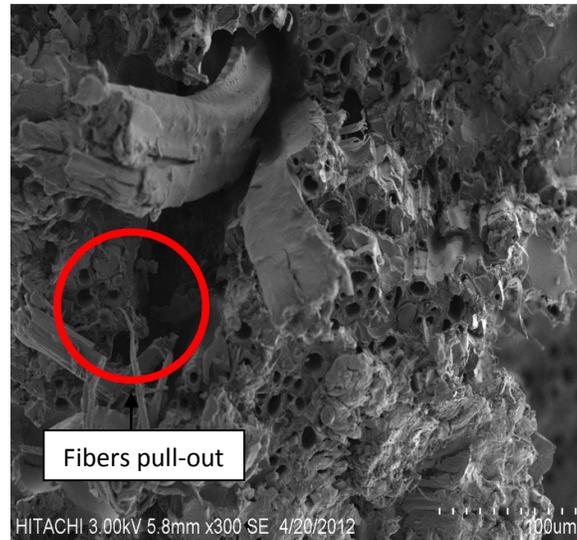
Figure 5: Fibre pull-out

Pockets of undispersed cross-linker may be caused due to incomplete curing in kenaf/epoxy composite materials. It was predicted that this specimen of kenaf/epoxy composites had a fibre pull-out when it experienced fatigue failure. Figure 5 shows fibre pull-out due to pockets of undispersed cross-linker.

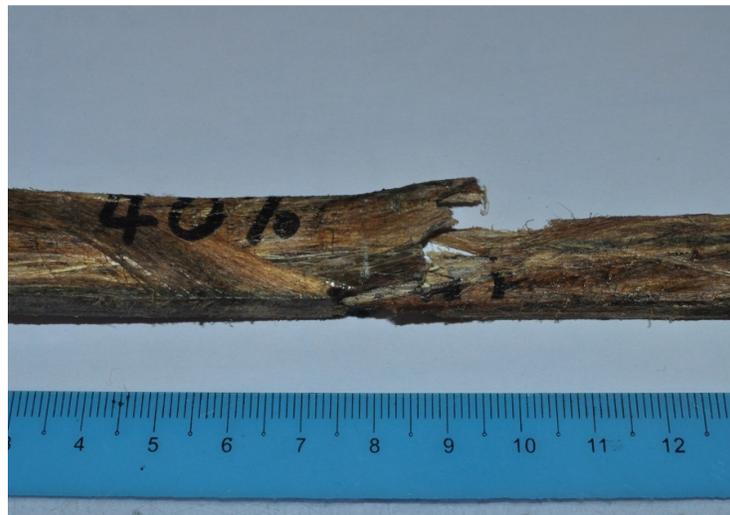
Figure 10: Specimen with 60% of kenaf /epoxy after fatigue test

Figure 10 shows the specimen with 60% of kenaf /epoxy after the fatigue test, while Figure 11 shows epoxy (matrix) cracking after fatigue tension-tension test was observed via SEM. SEM portrayed that a crack occurred in kenaf/epoxy when it experienced fatigue tension-tension loading in specimens with 60% of kenaf/epoxy. Besides, it was observed that fatigue damage development of kenaf/epoxy composites began with filler/matrix interface failure, followed by initiation and propagation of matrix, cracks from the filler matrix cracks from the filler/matrix debonding site, and subsequent development of longer matrix cracks from shorter cracks that
