## Effect of cold sprayed Al coating on corrosion behaviour of sponson spar

Cold spray, Sponson spar, Aging aircraft,  
Salt spray

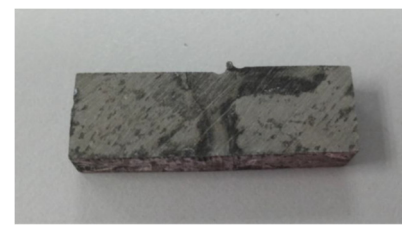
**Fig. 5.** Cold sprayed sample after SST

To investigate the corrosion resistant of cold sprayed substrate, the surface condition after salt sprayed testing for 48 hours are observed. Fig 2 and fig 4 shows surface conditions without any rust before SST conducted. Meanwhile, fig 3 and fig 5 show surface condition after SST conducted. Reference sample after SST covered with pitting corrosion, on other hand, cold sprayed sample after SST still remains clean without any rust. This condition maybe due to the deformation of other material by using cold spray can be the element to increase denseness of particle and reduce the corrosion defect. However, without the coating deformation, the tenseness to corrosion are highly deform at the surface of Al 7075 substrate. Al 6061 powder particles plays an important role in providing a corrosion protection against alternated salt spray environment [13].

This study set out to examine the relationship between corrosion properties of 7076-T6 fitting sponson spar and Cold Sprayed process. This study has identified that Cold sprayed process shows a significant corrosion treatment. The main findings can be summarized as follows, no localized corrosion shown on coated area after 48 hours salt spray testing and only tiny pores are seen on coating area compared to not coated area.
